Robustness of large-span timber roof structures – Two examples

Jørgen Munch-Andersen^a, Philipp Dietsch^{b,*}

This paper discusses the robustness of large-span timber roof structures, based on findings from failures of two roof structures. One is the Siemens arena in Ballerup, Denmark and the other the Bad Reichenhall ice-arena in Germany. The structures are described as well as the flaws that are believed to have caused the failures. The two cases serve as examples of different design strategies for large-span timber roof structures and the consequences of such strategies for robustness. It is demonstrated that robustness is not a straightforward concept because the best strategy depends on the cause of the failure – which was obviously not known during planning and design.

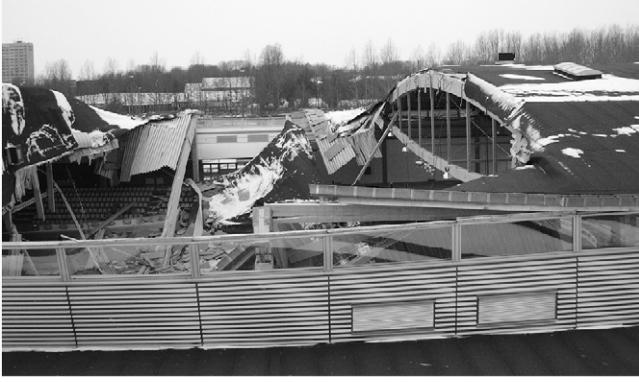
Two of the trusses collapsed without warning at a time with almost no wind and only a few millimetres of snow. The partial collapse happened just a few months after the inauguration of the arena. No people were present in the arena during the collapse.

Fig. 1. The Siemens arena roof structure after the collapse of two trusses. An intact truss can be seen on the right.

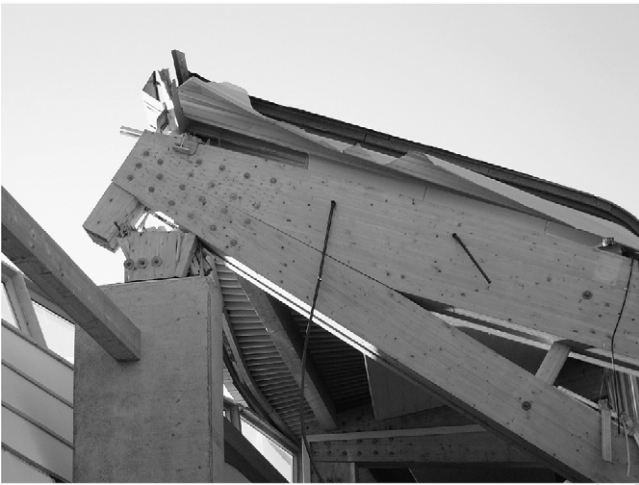
- The design strength used for the timber part was almost 50% too high.
- The reduced height of the cross-section near the ends of the arches, see Fig. 2, was not considered.
- The reduction of the timber cross-section due to steel plates, bolts and dowels, see Fig. 3, was not considered.

Fig. 2. Corner connection with concealed steel plates, connecting the timber parts through bolts (visible) and dowels (not visible).

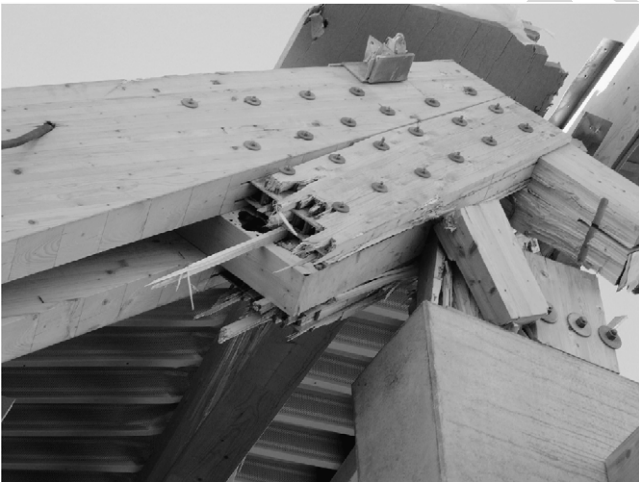
An investigation, see [1], showed that the cause of the failure could be localised to one critical cross-section in the tension arch near the support, where the load bearing capacity was found to be between 25% and 30% of the required capacity, see Fig. 3. By mistake, this cross-section was not considered at all in the design. Three critical design errors were identified:

The expected short term load-carrying capacity at the critical cross-section happened to be only slightly larger than the loads from the self weight of the structure. Because the strength of timber is reduced over time when it is loaded (the k_{mod} -effect), it is likely that the collapse took place when the strength was reduced due to the stresses caused by the self-weight. According to Eurocode 5 [2] and confirmed by Hoffmeyer and Sørensen [3], the reduction factor for medium duration loads (1 week to 6 months) is $k_{mod} = 0.8$. Such a reduction is enough to explain how the collapse could take place at a time with no special external load.

Fig. 3. Rupture at the critical cross-section in the corner connection. Note the dowels and steel plates.

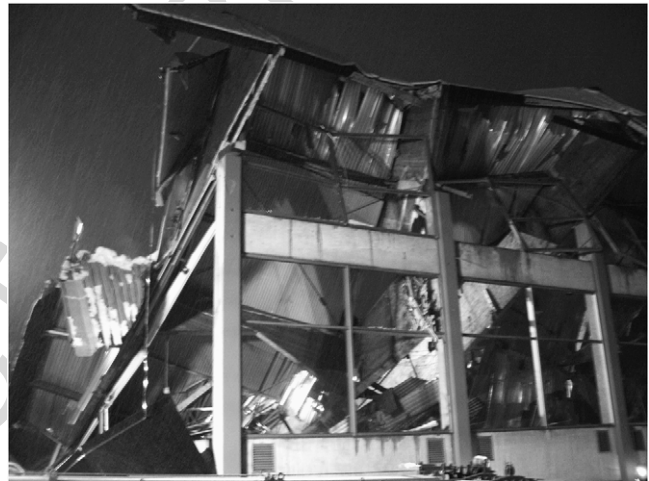
Fig. 5. Partial view of the collapsed roof structure.

On January 2nd 2006, the entire roof collapsed **without warning** – during a period of significant snowfall, see Fig. 5. However, the snow load was not above the characteristic snow load used in the design.

the general finger joints in the lower girder and the bonding between the girders and the web-boards. It was found that in some cases, there was no adhesive effect to a depth of 50–80 mm in the lower girders. In combination with the errors in the structural calculations, this represents the most significant cause for the collapse of the Bad Reichenhall ice-arena.

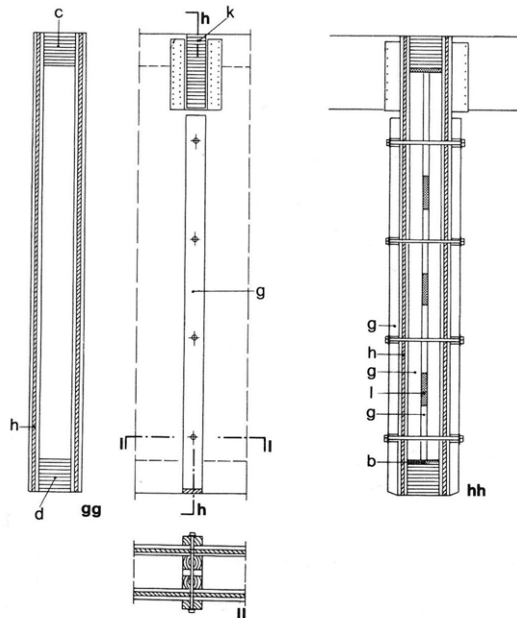
see Figs. 4 and 6. The roof was supported by 2.87 m high main girders, which were produced as timber box-girders, see Fig. 7. The box-girders featured upper and lower glulam members and lateral web boards made from so-called “Kämpf web boards” – a type of cross-laminated timber. The 48 m long girders were produced from three 16 m long sections, which were joined with general finger joints [5].

The review of the structural calculations revealed two important errors. For the assessment of the load-bearing capacity of the box-girder, the bending strength of the glulam was applied, rather than the tensile and compressive strength of the lower and upper girders. In addition, the weakening of the cross-sections due to the general finger joints between the girder parts as well as the web-boards was not taken into account in the structural calculations. Comparative calculations, based on the technical rules

37 Due to the humidity exposure over the years, the glue-lines and
 finger joints were significantly damaged. This primarily affected

Fig. 7. Cross-section of the box-girders in the ice-arena (from [5]).
