FIRE SAFE SERVICE INSTALLATIONS IN TIMBER BUILDINGS

Norman Werther¹, Michael Merk², René Stein³, Stefan Winter⁴,

KEYWORDS: Fire exposure, Service installations, Penetration sealing, Timber buildings

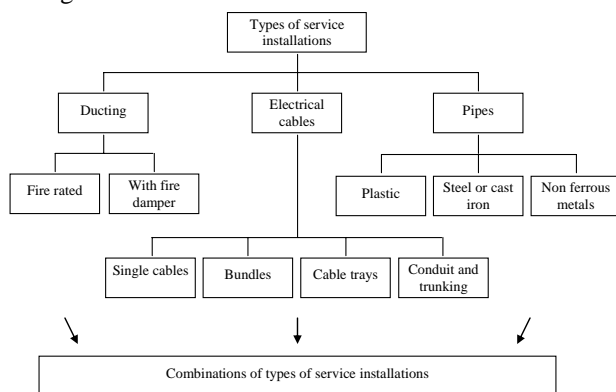
Figure 2: types of service installations

For the selection and arrangement of an adequate penetration sealing system the services must be classified under consideration of number, size, material of the supply lines and transported substances. Thus the service installations and sealing systems can be distinguished as follows.

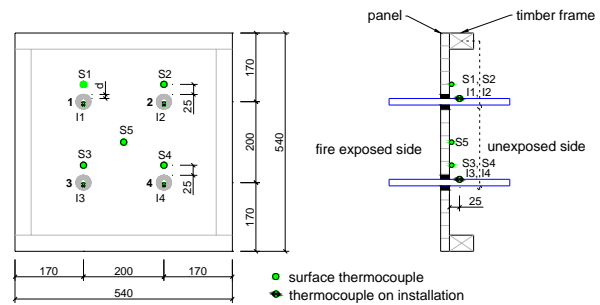
Figure 3: setup fire tests for sealing compounds

The tests were carried out under variation of panel thickness, type of sealing, size of annular gap (0 - 10 mm) and number of electrical wiring per penetration. In each test four different sealing setups were assessed (see Figure 3).

The temperature formation on unexposed side was measured with type K thermocouples at each cable and 25 mm beside the penetration area as well as in the centre of the OSB panel (see Figure 3), to compare the failure times at penetrations and the plane undisturbed panel to each other.

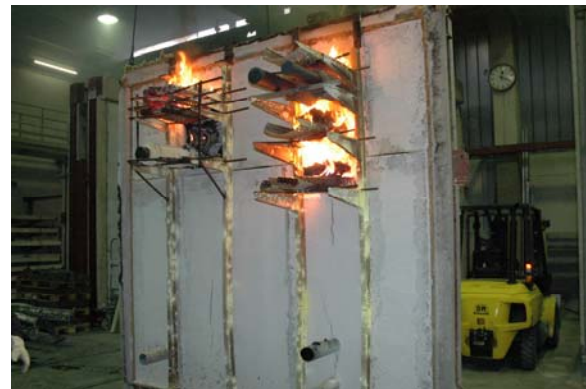
Figure 6: full scale fire tests of wall assembly with multi penetration sealing systems after fire test (picture DGFH)

In addition, two full scale fire tests with a timber frame wall and floor assembly in combination with a mineral wool board multi penetration sealing system and installed services were conducted [9], [10]. Before lining the reveal areas a support infill frame was attached in the opening of the timber frame wall and floor, to stabilise and support the gypsum plasterboard cladding. For these fire tests two layers of 18 mm gypsum plasterboards were used to line the reveal area. The wall and floor assembly were also lined in the entire exposed surface with the same plasterboards.

These full scale fire tests were carried out in accordance with EN 1366-3 and under ISO 834 fire curve exposure. The failure criteria in all tests were measured in terms of:

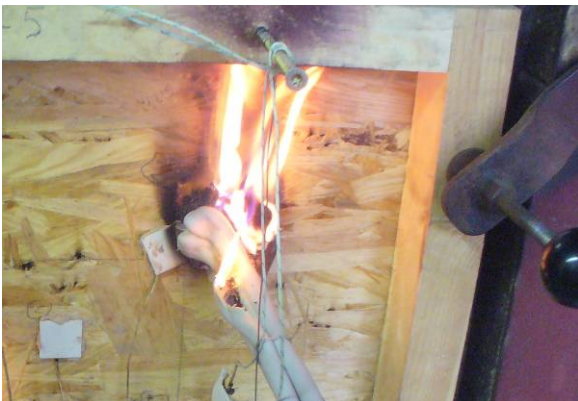
Figure 8: ignition at unexposed side

All conducted tests showed larger heat transfer through the cables itself in comparison to the plane panels and sealing compounds. As expected, an increase in the number and conductor diameter led to an increase of heat transfer throughout the cables and faster temperature formation in the penetration area. For one cable bundle an early ignition at unexposed side of the OSB lining occurred (see Figure 8).

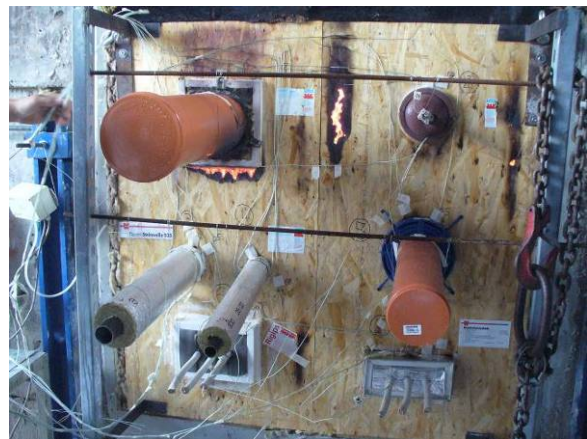
Figure 9: failure of small scale timber frame assembly (EI 30) after 43 minutes

As for the sealing compounds excellent results have also been reached for approved penetration sealing systems in timber structures [11], [13]. Therefore equal failure times for the plane timber elements and penetration areas have been guaranteed (see Figure 9).

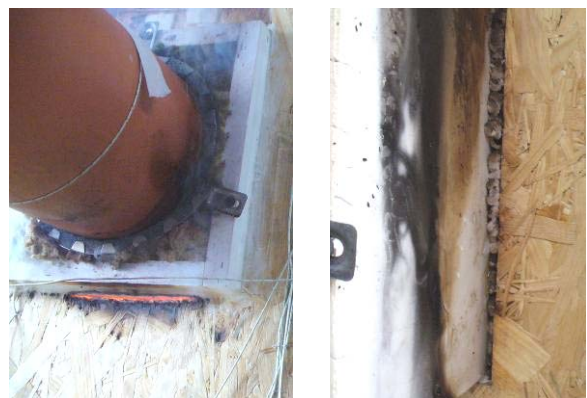
Figure 10: failure in sealed penetration junction (left); insufficient sealing with gypsum putty (right)

As the most critical area for an early failure, the junction of penetration sealing system and timber element was found in all tests. This has been caused by problems to fill the joints in the entire depth of the lining (see Figure 10).

This problem was more significant for multilayer and thick linings in combination with gypsum putty or mastics when compared with intumescent sealing compounds. Here gaps and small voids in the sealed joints were subsequently closed by thermal expansion of the intumescent material.

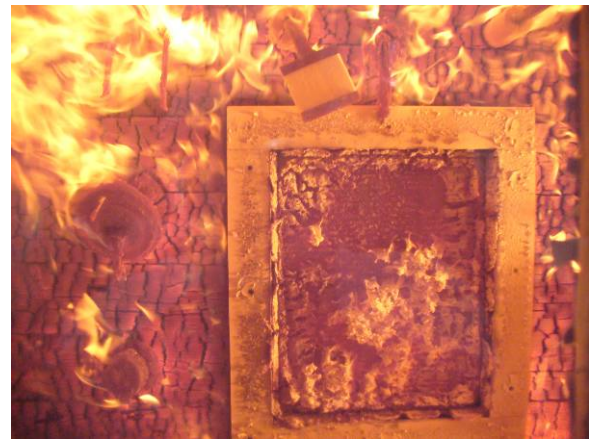
Figure 13: fire test at CLT element with lined and framed reveal area

Due to these results the setups for the fire tests were derived. The thermal degradation of the timber members was accepted in the area of exposed corner. In this manner designed and conducted reveal areas showed excellent performance under fire exposure in combination with the 100 mm wide framed lining.

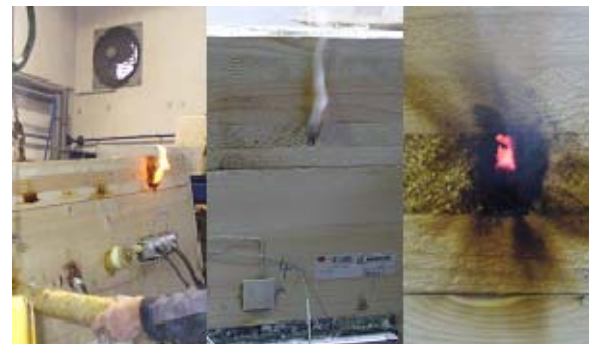
Figure 14: flame spread caused by gaps in CLT elements

During the tests with CLT elements flame spread alongside inner gaps took place and finally reached the unexposed side in the wall-floor junction (see Figure 14). These gaps in the CLT elements are typical and are caused by a lack of bonding of the inner layers at the narrow sides.
