# Experimental lifetime study of regeneratively cooled rocket chamber walls

A detailed knowledge of the life-limiting mechanisms of regeneratively cooled rocket combustion chambers is important to increase the safety, the thrust-to-weight ratio and the cost-efficiency of future rocket engines. For this purpose, an actively cooled specimen made of CuCr1Zr is mounted downstream of a combustion chamber. The specimen is loaded cyclically and inspected after each cycle. The specimens collapse in the 'doghouse' failure mode after several load cycles. The effects of different hot-gas and coolant conditions, surface roughness and thermal barrier coatings on the lifetime are studied. The life-limiting mechanisms: creeping, yielding, abrasion, blanching and thermal aging are discussed.

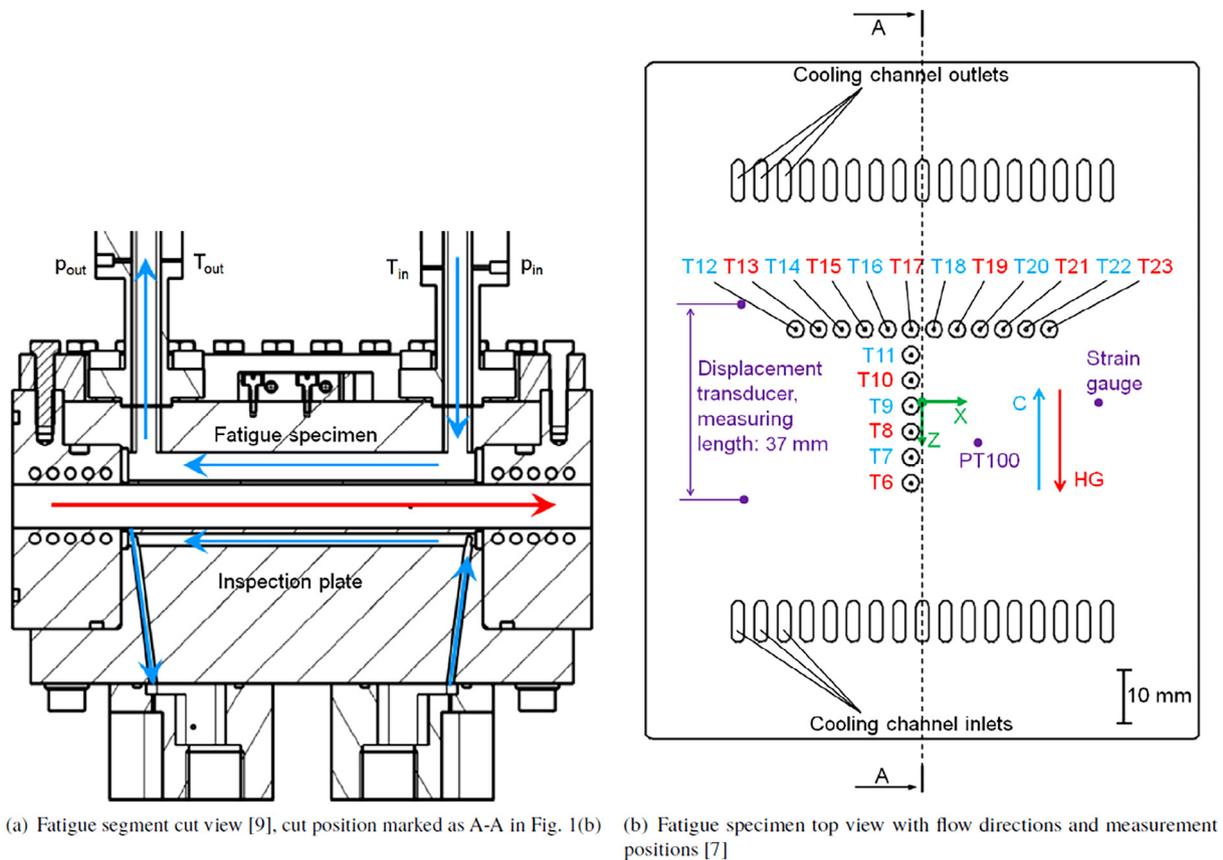
Fig. 1. Experimental setup.

Fig. 1(a) shows a cut view of the fatigue segment and visualizes the fluid flows (red for hot-gas, blue for coolant). The fatigue segment includes a replaceable fatigue specimen made of the copper alloy CuCr1Zr. The specimen is attached with a floating bearing which allows free thermal expansion. It has 17 rectangular cooling channels with a height of 8 mm, a width of 2.5 mm, a rib thickness of 2 mm and a length of 96 mm. The wall thickness between the hot-gas exposed surface and the cooling channel bottom side is 1 mm. The specimen is loaded cyclically. After each cycle the deformation of the specimen's hot-gas wall is measured by a laser profile scanner. To inspect the hot-gas exposed surface without the need to disassemble the fatigue specimen, the water-cooled inspection plate on the opposite side is removed.

High pressure nitrogen at ambient temperature is used as coolant for the specimen. To ensure well defined conditions in the three central cooling channels the mass flow rates here are closed loop controlled individually (PID). The coolant supply for the remaining 14 channels are separated in two closed loop controlled lines. The mass flow rates in each of these five supply lines are measured by a Coriolis flow meter located downstream of the fatigue specimen. Also the inlet pressure is regulated by a PID-control. The temperature and pressure of the coolant are measured in the inlet and outlet manifolds of the three central and two additional cooling channels by thermocouples respectively pressure transducers (see Fig. 1(a)).

Furthermore, the specimen is equipped with several thermocouples in different positions and depths to measure the temperature distribution in the structure during each cycle. Fig. 1(b) shows the top view of the fatigue specimen with the green coordinate system in the center. In addition, the thermocouple positions T6-T23 (red for 3 mm and blue for 5 mm distance to the hot-gas exposed surface) are shown. The most central located thermocouple T9 has the coordinates  $x = -2.25$  mm/

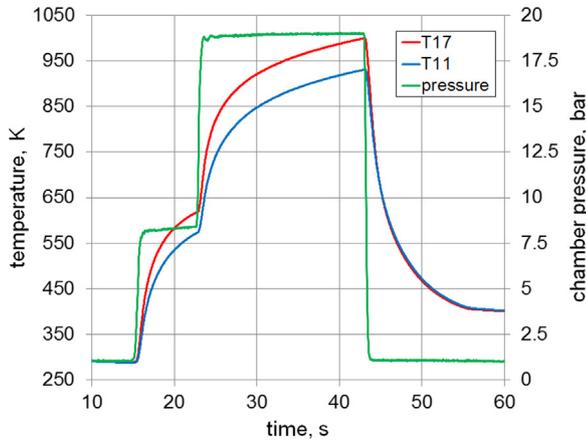
Fig. 2. Averaged temperature and pressure transients during Campaign C.

A load cycle consists of three phases: pre-cooling, fire and post-cooling phase. For ignition reliability, controlled flame anchoring and combustion stability the fire phase consists of two different chamber pressure stages. Fig. 2 shows the chamber pressure and the temperature of thermocouples T11 and T17 averaged over all cycles of Campaign C. The position of the thermocouples can be found in Fig. 1(b). After start of the fire phase the pressure increases rapidly until an almost steady-state hot-gas status is reached (ignition stage). After 7.5 s the pressure increases and holds the nominal load for 20 s (nominal stage). In the post-cooling phase the combustion is stopped by closing the propellant supply and the chamber cools down. Both thermocouples respond to the thermal loads with rapidly increasing temperatures. T17 reaches higher temperatures and responds faster due to its smaller distance (3 mm) to the hot-gas exposed surface than T11 (5 mm).

As Fig. 2 indicates, the chamber pressure has a large impact on the thermal loading. After the widely used Bartz equation [16] following relationship between the heat transfer coefficient  $\alpha_{hg}$  and the chamber pressure  $p_{hg}$  applies:

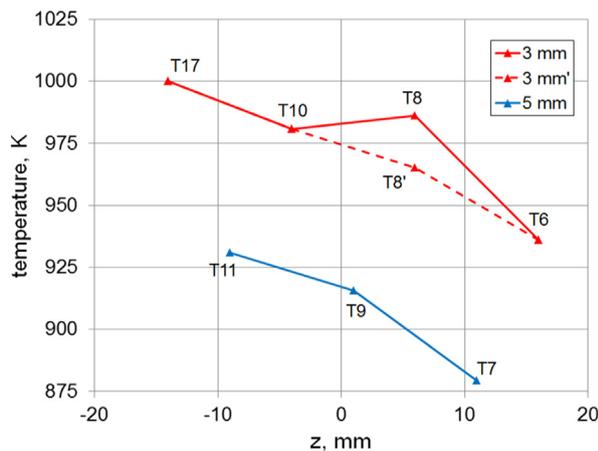
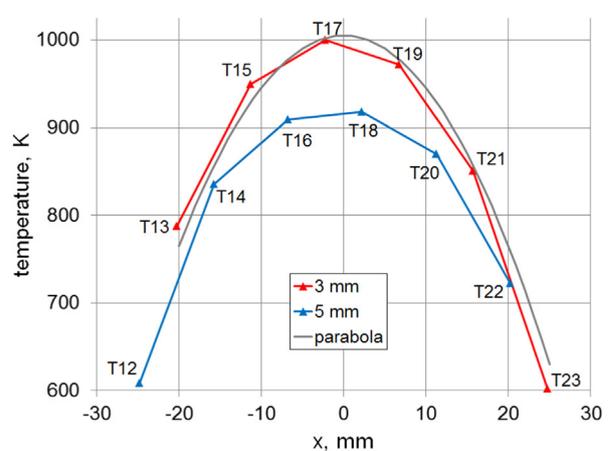
**Fig. 3.** Averaged temperature distribution at the extinction time point for Campaign C.

Fig. 3 shows the temperature distribution in the specimen at the end of the second stage averaged over all cycles of Campaign C. The temperature distribution is qualitatively representative for all test campaigns. The temperature is decreasing in hot-gas flow direction (z-direction). This is mainly caused by the strong cooling effect of the impinging nitrogen in the cooling channel inlet region (at z = 44 mm). In addition the nitrogen temperature is increasing in its flow direction (negative z-direction). The thermal boundary layer of the hot-gas is increasing in z-direction, which reduces local heat fluxes. The axial temperature gradient between T6 and T17 is approximately 2.4 K/mm.

The vertical temperature gradient at a distance of 3 mm (red curves) to 5 mm (blue curve) to the hot-gas exposed surface amounts to roughly 30 K/mm. Assuming this gradient to be constant, the extrapolated temperature of T17 reaches 1090 K at the surface exposed to the hot-gas. Thermocouple T8 reports higher temperatures than expected. This is due to a manufacturing error, causing T8 to be positioned at just 2.3 mm instead of the nominal distance of 3 mm to the hot-gas exposed surface. Applying said temperature gradient of 30 K/mm, the measured temperature is 21 K too high. T8' indicates the temperature corrected by this value, which seems realistic. The depths of the remaining thermocouples are inside the manufacturing tolerance of +/- 0.2 mm, which results in a +/- 6 K uncertainty. The thermocouples have a measuring tolerance less than 4 K at 1000 K and a response time less than 0.15 s.

The transverse temperature distribution (Fig. 3(b)) decreases away from the symmetry axis, since the hot-gas velocity and temperature are decreased in the corner regions of the chamber. This again leads to a decreased heat flux and therefore reduced wall temperatures in those regions. Furthermore, the three outermost cooling channels on both sides overhang the hot-gas cross section. The temperature profile at a distance of 3 mm to the hot-gas exposed surface can be approximated with a parabola of equation  $T(x) = -0.6x^2 \cdot K/m^2 + 1005K$ . A comparison of the thermocouple measurements with the (symmetric) parabola shows a slight asymmetry. The asymmetric temperature distribution causes an asymmetric deformation profile, as shown in Fig. 6(a). The temperature distribution at the hot-gas walls upstream of the fatigue segment is verified to be asymmetric as well. Therefore, it is concluded that this is caused by the hot-gas flow, possibly by a non-uniform fuel

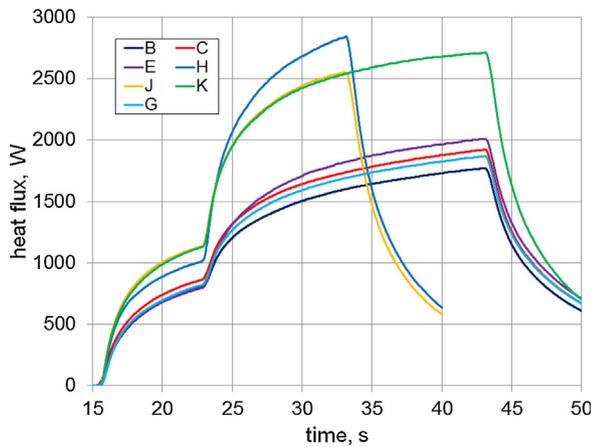
Fig. 4. Averaged integral heat flux transients of the central cooling channel for selected test campaigns.

Fig. 4 shows the averaged integral heat flux transients of the central cooling channel during campaigns B-K. The heat flux is calculated by the product of the specific heat capacity, the mass flow and the difference of the inlet to the outlet temperatures of the nitrogen. The change of enthalpy due to change of pressure is neglected, since the pressure drop in the cooling channels is merely around 0.1 bar. When a steady-state behavior is reached, the calculated cooling channel heat flux corresponds nearly to the heat flux over one rib and one cooling channel width in the center of the hot-gas exposed surface of the specimen. The nitrogen temperatures are measured at the manifolds. The thermocouples as well as their positions remain the same in every test campaign, as the manifolds are not replaced after each of the test campaigns. The position and the contact of the thermocouples in the specimen depend on manufacturing accuracy. Because of the extremely high temperature gradients in space as well as time, small differences can cause large errors. Therefore, the nitrogen temperatures are rather to be used for relative comparison of test campaigns in terms of the thermal loading.

At the end of the fire phase, the heat flux into the central cooling channel averages to 1922 W in Campaign C. Assuming steady-state behavior, this corresponds to a heat flux density at the hot-gas side of  $4.27 \text{ MW/m}^2$ . In Campaign B this value is 7.9% less, caused by the 9.5% lower chamber pressure and a slightly lower mixture ratio. In Campaign E, the increased surface roughness causes a 4.5% higher heat flux despite a slightly lower mixture ratio. The thermal barrier coating in Campaign G reduces the heat flux by 2.8%. The 50% higher chamber pressure, the much lower mixture ratio and increased roughness in Campaign K result in a 41.1% increase of heat flux. The almost identical heat flux curves of campaigns J and K along the entire first 17.5 s of operation indicate an excellent repeatability of the thermal loads. The maximum heat flux of the central cooling channel in Campaign H is 11.4% higher than in Campaign J, caused by the higher mixture ratio.

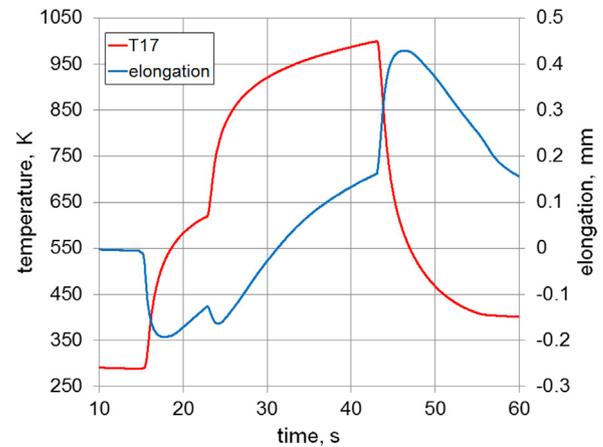
Fig. 5. Averaged temperature and elongation transients during Campaign C.

The hot-gas wall of the specimen has to resist three load phases during a load cycle. These load phases are marked in Fig. 5 and described below:

1. Ignition and stage change (during  $15 \text{ s} < \text{time} < 17.6 \text{ s}$  and  $23 \text{ s} < \text{time} < 24.2 \text{ s}$ ): After ignition respectively stage change the temperature of the hot-gas wall increases rapidly which thus expands. The rest of the structure is still cold and restrains this expansion. As a result, the hot-gas exposed surface bends convexly while the upper side of the specimen bends concavely, which

decreases the distance between both measurement cantilevers of the displacement transducer, as shown in Fig. 5. Very high in-plane compression stresses are induced into the hot-gas wall due to the thermal loading. In addition, the walls between coolant and hot-gas bulge into the hot-gas due to the large pressure difference. In combination with high temperatures and time, this leads to creeping. Due to the short duration and low temperatures in comparison to the other phases creeping can though be neglected in phase 1.

2. Hot phase (during  $17.6 \text{ s} < \text{time} < 23 \text{ s}$  and  $24.2 \text{ s} < \text{time} < 43 \text{ s}$ ): Afterwards, the heat reaches the back parts of the structure and the thermally induced stresses decrease, until a steady-state is reached (not reached in the tests). As the specimen is actively cooled, the in-plane compression stresses in the hot-gas wall however would not reach zero. The bending now decreases, as the entire specimen expands thermally. Therefore, the measured elongation increases (see Fig. 5). In contrast to phase 1 and 3 creeping is important, since the thin hot-gas wall has to resist the pressure differences between hot-gas and coolant as well as compressive stresses due to the temperature differences (see above) during a comparatively long duration, while exceeding temperatures of 1000 K. Additionally, blanching, abrasion and thermal aging can be present in this phase.

3. Shutdown phase (during  $43 \text{ s} < \text{time} < 46 \text{ s}$ ): After shutdown the temperature of the hot-gas wall decreases much faster than the rest of the structure due to the low heat capacity of the thin wall as well as the high heat flux to the impinging coolant. This leads to very high in-plane tensile stresses and a concave bending of the hot-gas exposed surface, which rapidly increases the measured elongation on the upper side (see Fig. 5). Because of the change in load direction a Bauschinger effect [18] occurrence must be assumed, which decreases the tensile yield strength. In this phase creeping can again be neglected, due to quickly decreasing temperatures. After 46 s, the measured elongation decreases. This indicates that the vertical temperature difference decreases, which in turn reduces the bending of the specimen and in-plane tensile stresses. As the temperatures fall below 600 K, the yield strength is increased. In conclusion the loading after 46 s can be neglected.

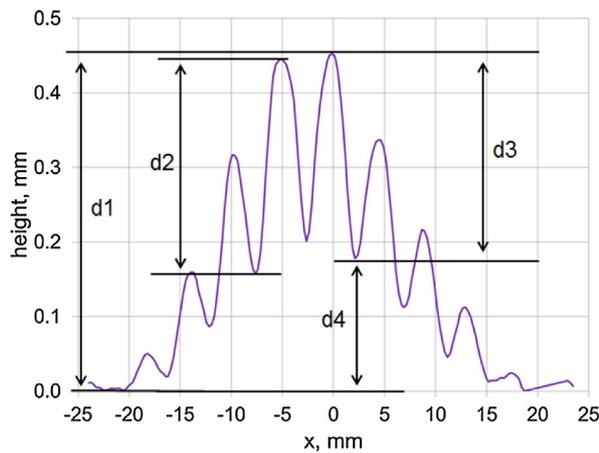
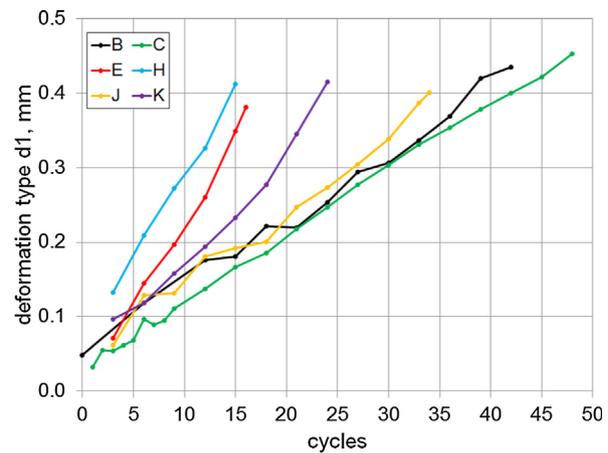
**Fig. 6.** Deformation measurement.

Each underlying deformation profile is measured 20 mm downstream from the leading edge of the specimen using a laser-profile-scanner in transverse direction. The deformation measures are defined in Fig. 6(a), where the measured profile at the end of Campaign C is shown. Deformation type d1 is the difference of the global maximum and global minimum. Deformation type d2 is the overall greatest difference of a local maximum and a neighboring local minimum. Deformation type d3 is the greatest difference of the global maximum and a neighboring local minimum. Deformation type d4 is the difference of type d1 and d3. Neighboring means a distance smaller than 4.5 mm (one channel plus one rib width).

Fig. 6(b) shows the development of the type d1 deformation during campaigns B, C, E, H, J and K. It is shown that the deformations are increasing almost linearly with the number of cycles in all test campaigns.

Despite different load conditions, the doghouse effect occurs reproducibly, when a deformation type d1 height of around  $40\mu\text{m}$  is reached. For test campaigns with low loading (B, C, D, G) the critical value is slightly higher (approximately  $45\mu\text{m}$ ). The critical deformations of types d2 and d3 are roughly  $30\mu\text{m}$ . The average slope of deformation is increasing with temperature gradient and level.

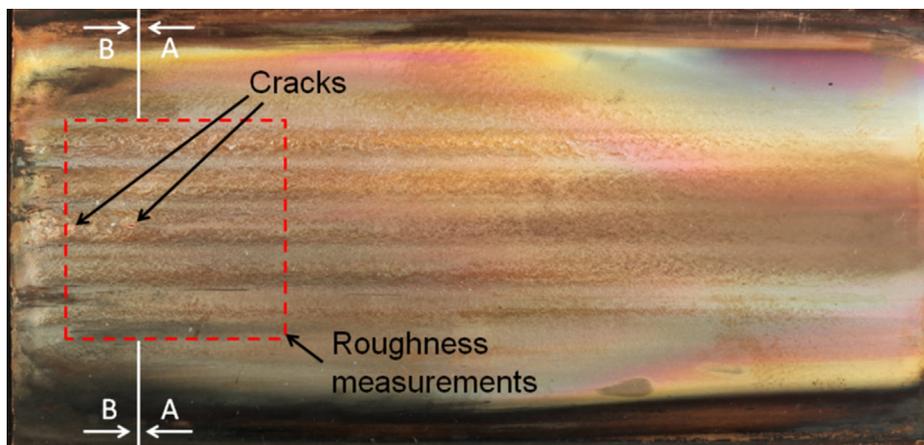
Fig. 7. hot-gas exposed surface after 48 cycles (Campaign C).

Fig. 7 shows the hot-gas exposed surface of the fatigue specimen

after 48 cycles (1320 s of fire phase in total) in Campaign C. Two cracks are visible at the wall of the central cooling channel. To investigate these cracks, the fatigue specimen has been cut at the crack tip. Fig. 8 shows the cut views A-A and B-B (marked in Fig. 7) through the five central cooling channels. Due to material removal by the utilized saw blade and the metallographic preparation, both cut views differ slightly in their axial positions. In cut view A-A the cooling channel wall has already failed, whereas the crack in cut view B-B has not yet reached the hot-gas exposed surface. Both cracks are shown in Fig. 9 in detail. The original shape of the cooling channel and the micro structure is shown as overlay in Fig. 9(a). The strong plastic deformation of the micro structure indicates necking caused by tensile loads.

$R_a$  is measured along lines in flow direction ( $0^\circ$ ) and transverse to it ( $90^\circ$ ), both at nine different locations in the red dotted quad in Fig. 7. This quad is subdivided in nine equal quads, and the measurements are performed in the centers of these quads along 4 mm long tracks.

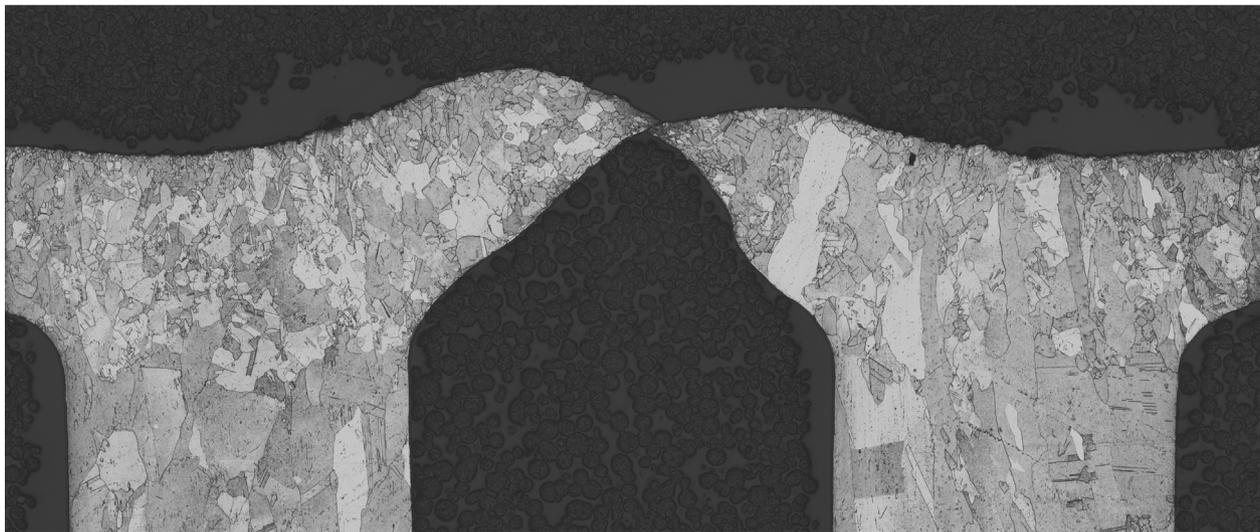
Fig. 10. 'Doghouse' failure in Campaign E (etched micro structure).

Fig. 10 shows the 'doghouse' failure and micro structure in the central cooling channel wall in Campaign E. In comparison to Campaign C the material has had a larger initial grain size. Along the hot-gas exposed surface the material has strongly degraded due to sand-blasting in provocation of the higher initial surface roughness. The leakage due to the 'doghouse' failure (in cold state) and the crack length are extremely small in Campaign E. Therefore it can be concluded that this 'doghouse' failure occurred very shortly before the campaign was ended. The 'doghouse' shape is not symmetrical, which is a consequence of the non-uniform grain size distribution.

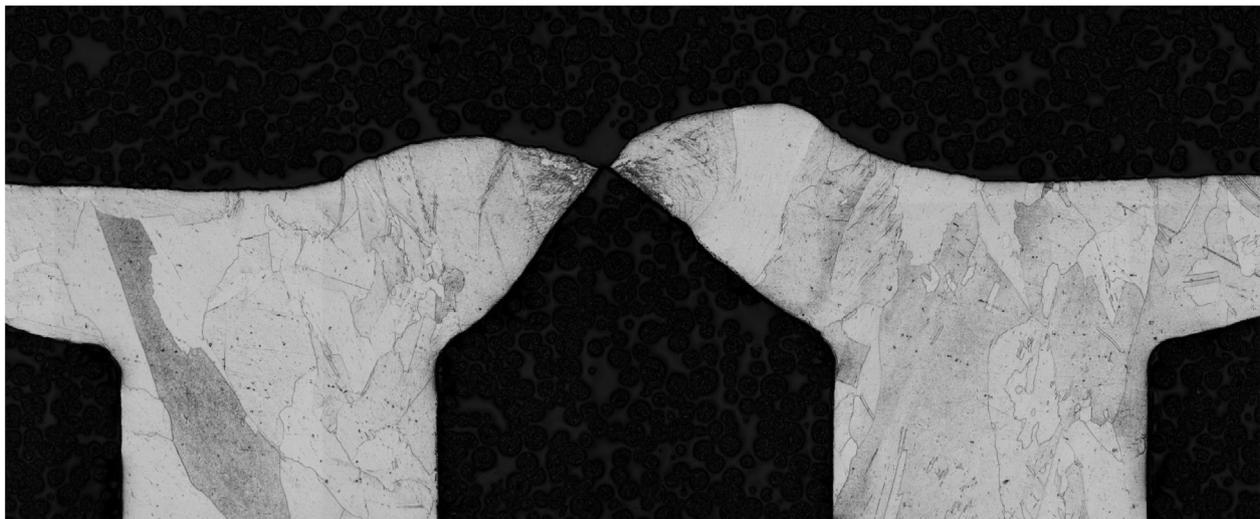
Fig. 11. 'Doghouse' failure in Campaign H (etched micro structure).

Fig. 11 shows the 'doghouse' failure in the central cooling channel wall and its micro structure in Campaign H. The initial grain size is very large. The effect of the grain size on the lifetime is still not clear and will be investigated in the future. On one hand, large grains reduce creeping, since that effect occurs predominantly on the grain boundaries and larger grains lead to less thereof. On the other hand, large grains increase the appearance of yielding, since it occurs through

dislocation motion and grain boundaries mitigate such motion.

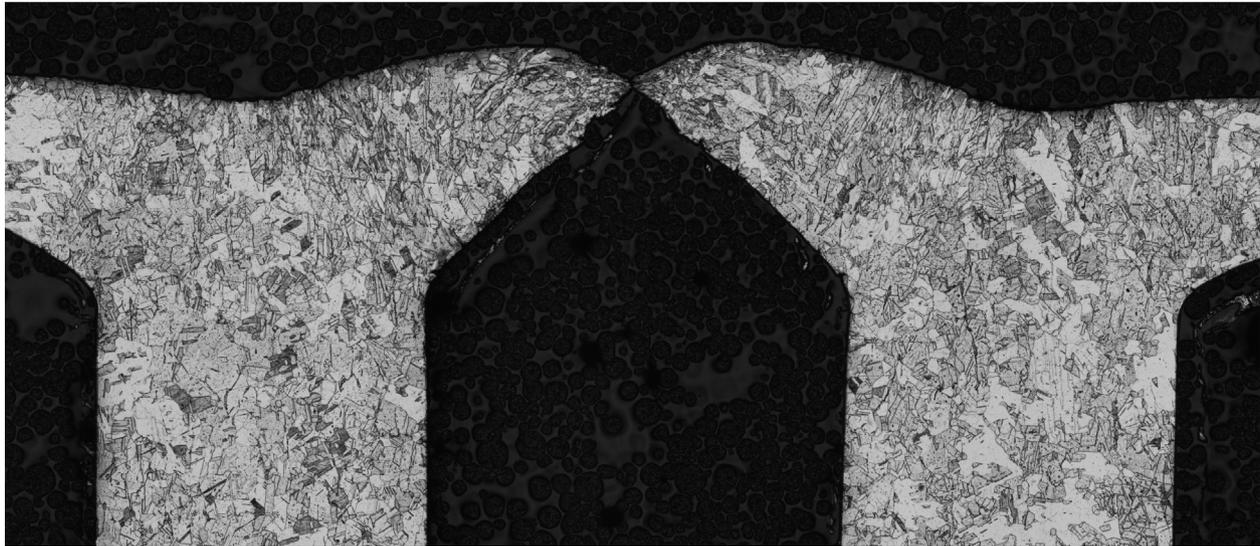
Fig. 12. 'Doghhouse' failure in Campaign J (etched micro structure).

Fig. 12 shows the 'doghouse' failure in the central cooling channel wall and the surrounding micro structure in Campaign J. The initial grain size is comparable to that in Campaign C. In contrast to campaigns E and H the roof of the 'doghouse' is very straight and symmetric, due to its small grain size and very uniform grain distribution.

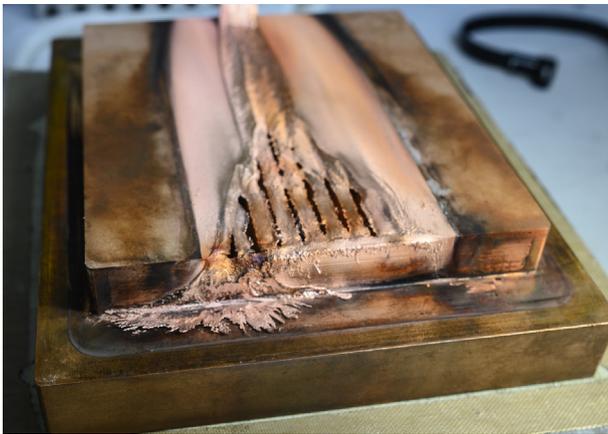
Fig. 13. Melted hot-gas wall in Campaign I.

In Campaign I the hot-gas wall melted during the second load cycle in a large area (see Fig. 13). During the main stage of the second cycle the integral wall heat flux of the central cooling channel was 7% higher than in all other tests and 11% higher than in the first cycle of Campaign I. The mixture ratio (3.96) and pressure (28.8) were almost the same as during the first cycle (3.93 respectively 28.6). No manufacturing error could be detected in the remaining material. Therefore, it is assumed that a combustion instability has increased the heat flux significantly and that a critical wall temperature has been reached, which caused a rupture due to the pressure difference between coolant and hot-gas. The fact that the material failed during the fire phase and not during the post-cooling phase supports the hypothesis that the failure was caused by pressure rupture and not by fatigue. It is assumed that a massive leakage in one cooling channel has reduced the drag of this coolant line. This would decrease the coolant's mass flow of the other cooling channels and would therefore increase the wall temperature of other parts of the specimen towards the critical temperature.

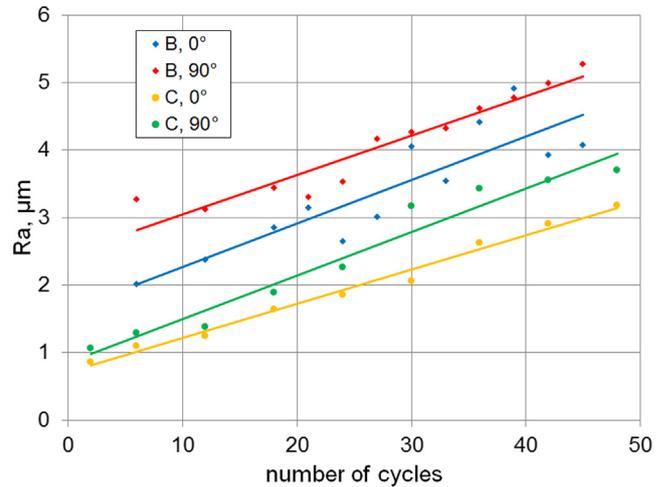
Fig. 14. Roughness development.

Fig. 14 shows the roughness development on the hot-gas exposed surface of the specimen during campaigns B and C. The values of both measurement directions are averaged over the nine measurement locations. The initial roughness before the first hot-gas test is  $R_a = 0.5 \mu\text{m}$

in campaigns B and C (see Table 2). In Campaign C the roughness increases nearly linearly. In Campaign B the roughness increase during the first six cycles is much higher than in Campaign C. The further roughness development is much more erratic than in Campaign C. It is assumed that the combustion instabilities are the reason for that. Possibly, the instabilities during tests B2 and B4 are the reason for the much higher roughness after Test B6 in comparison to the roughness after Test C6. After that, the roughness in  $90^\circ$  direction decreases slightly in Campaign B until Test B12. This could be caused by flaking off of the reacted layers. During the tests B28-B30, a strong roughness increase in  $0^\circ$  direction is detectable, possibly caused by the instabilities in Test B30. After this, the roughness in  $0^\circ$  direction decreases until Test B33. It could be caused by flaking off of the reacted layers again.

It is still unclear, which effect causes the roughness increase in tests without apparent blanching in macroscale, like in Campaign C. It could be caused by microscale blanching, plastic deformation, thermal aging or abrasion. Plastic deformation can increase the roughness due to non-uniform deformation of the grains. Thermal aging can increase the roughness due to non-uniform grain growth or chromium precipitates. Abrasion can increase the roughness due to partial damage of the hot-gas exposed surface.

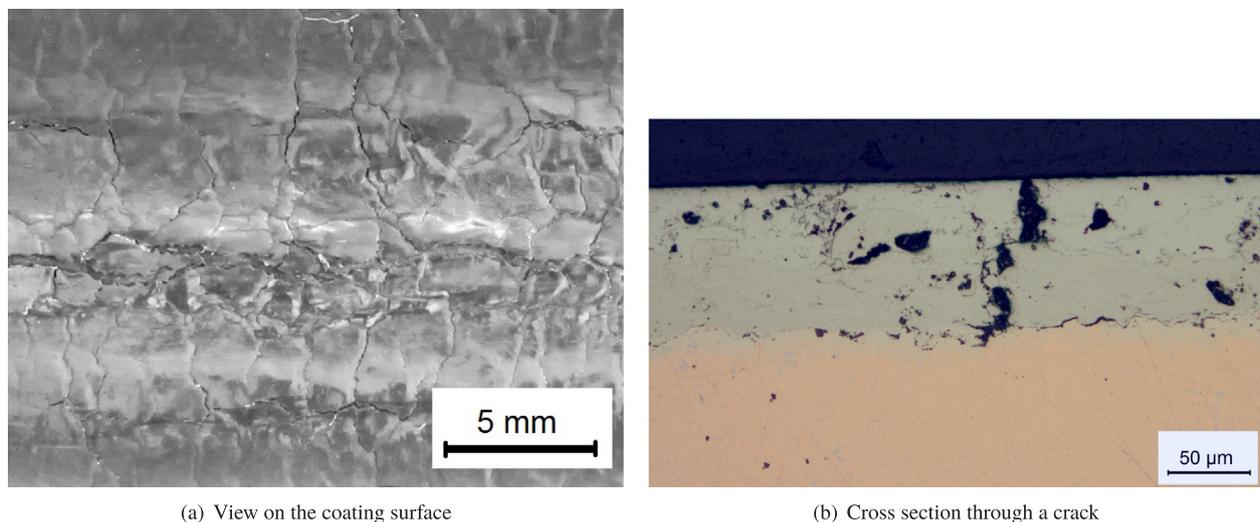
Fig. 16. Crack network in the coating after 36 test cycles (Campaign G).

A diffusion heat treatment enhances the adhesion strength of the coating and reduces the growth of delamination cracks. It is supposed that, if the delamination crack growth is hindered by this diffusion heat treatment, no buckling or large-scale delamination can be expected in the coatings [10]. After Campaign G, the diffusion heat treated coating showed neither buckling nor delamination even after 36 cycles, although a network of vertical (relating to the coating surface) cracks has formed in the entire coating (see Fig. 16). The mechanism of this crack

growth has been elucidated in detail in previous work [10]: At high temperature, the thermal expansion of the hot coating surface is constrained by the cooled copper substrate. This results in compressive strains that exceed the yield strength. Plastic deformation leads to a reduction of the elastic component of the strain, so that subsequent cooling generates large tensile strains, and the coatings may crack [10,22]. Cyclic loading leads to further crack growth, so that small cracks grow together and form a crack network, as observed after the 36 cycles of this test campaign.

Since the coating was still adhering to the copper substrate, it is supposed that these cracks can be tolerated in rocket engine applications. Furthermore, the larger heat flux in full-scale engines causes a larger temperature gradient in the coating that will lead to less thermal strains in the near-substrate part of the coating (see [10] for a more detailed discussion). Thus, cracks may stop upon reaching the substrate. But the exact mechanism of the propagation of vertical cracks, especially under cyclic loading, is not fully understood yet, and future work will focus on this crack propagation.
