Robustness of large-span timber roof structures – Two examples

Jørgen Munch-Andersen^a, Philipp Dietsch^{b,*}

This paper discusses the robustness of large-span timber roof structures, based on findings from failures of two roof structures. One is the Siemens arena in Ballerup, Denmark and the other the Bad Reichenhall ice-arena in Germany. The structures are described as well as the flaws that are believed to have caused the failures. The two cases serve as examples of different design strategies for large-span timber roof structures and the consequences of such strategies for robustness. It is demonstrated that robustness is not a straightforward concept because the best strategy depends on the cause of the failure – which was obviously not known during planning and design.

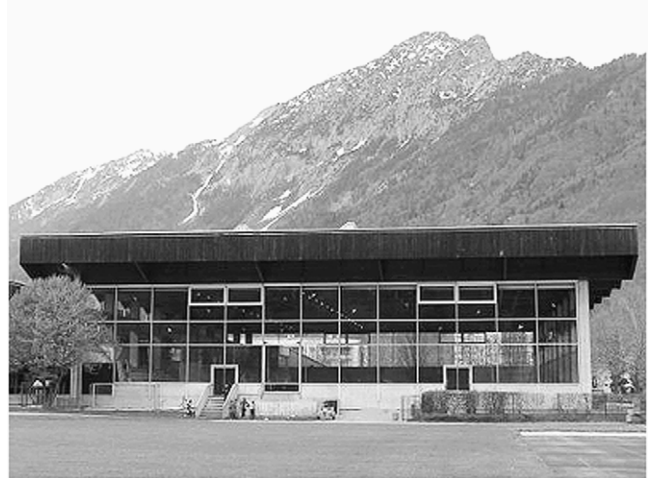
Fig. 4. The ice-arena in Bad Reichenhall.

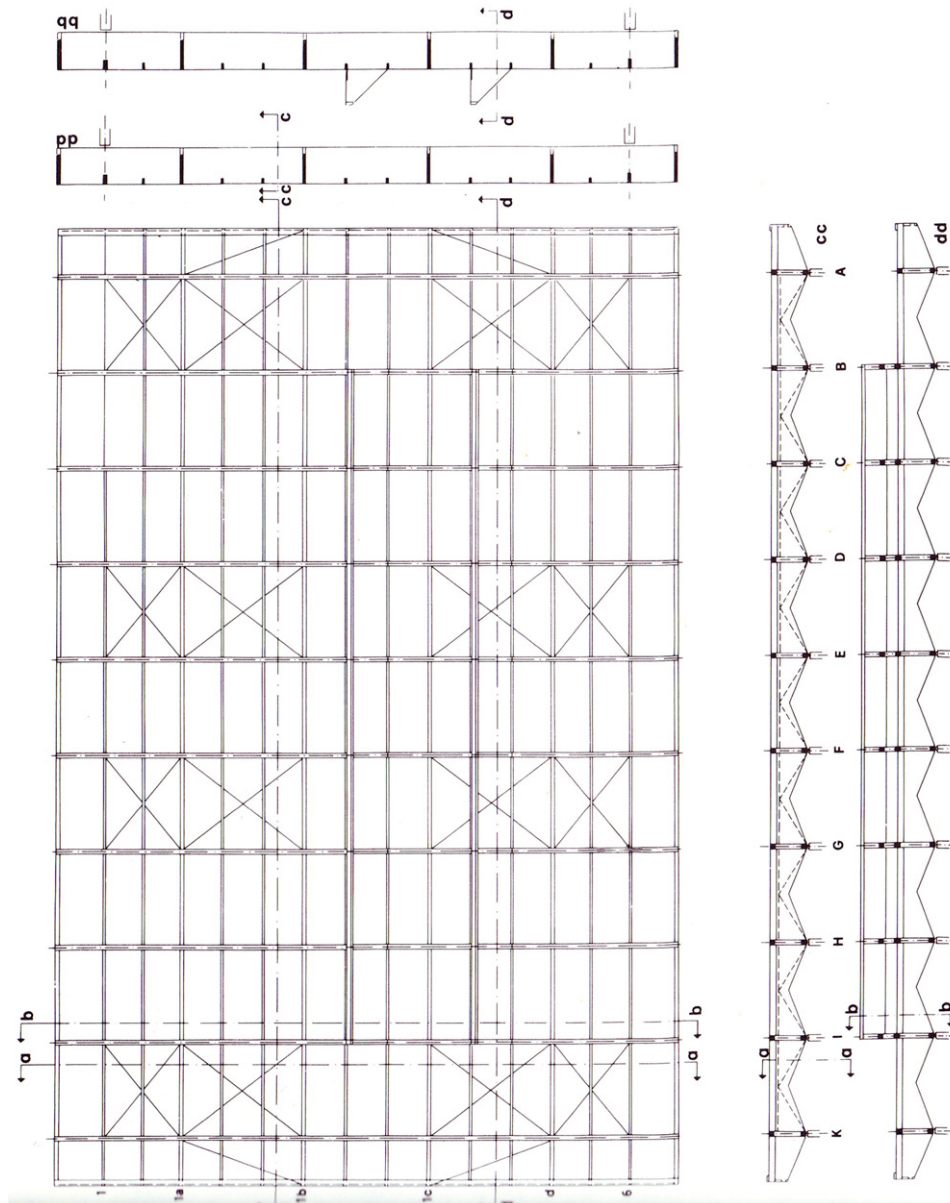
The secondary system was fixed to the sides of the girders and acted both as purlins and as lateral bracing (K-bracing) for the main box-girders, see Fig. 6. This enabled the roof structure to redistribute loads between the girders.

Fig. 6. Layout of the roof of the ice-arena and side view of the girders (from [5]).
